SUBJECT: Addendum No. 1
RFP No. HHSC FY 20M-0030
Walk-In Freezer Replacement for Maluhia

INSPECTION REPORT FOR ASBESTOS AND LEAD-BASED PAINT

MALUHIA NURSING HOME
WALK-IN FREEZER REPLACEMENT

EnviroQuest Project: 19453

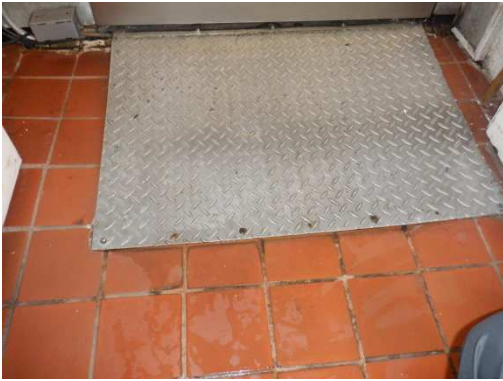
Photo 1: Non asbestos-containing red quarry floor tile and grout/ mortar adjacent to the freezer.

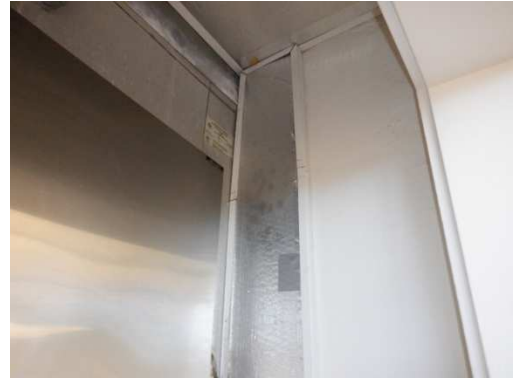
Photo 2: Non asbestos-containing silver foil/paper cover and red fiberglass wall insulation adjacent to the freezer.

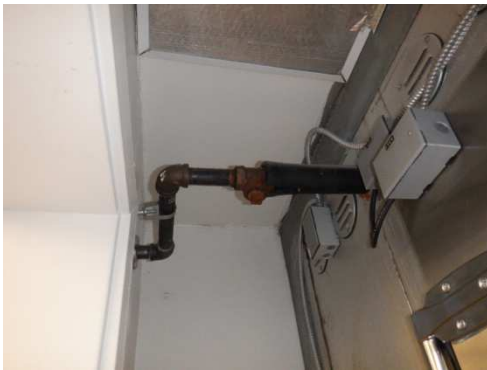
Photo 3: Non asbestos-containing beige plaster wall adjacent to the freezer.

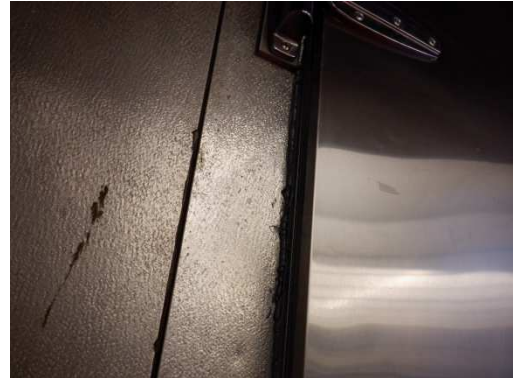
Photo 4: Non asbestos-containing gray caulking on freezer joint sealant.

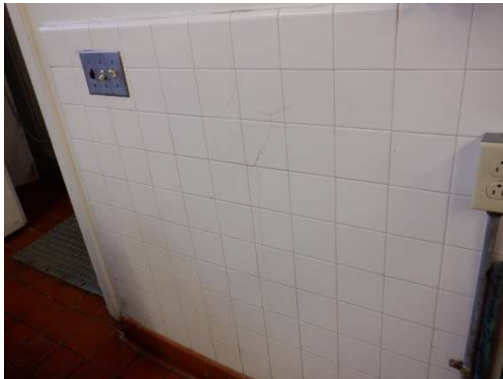
Material	Location	Condition
Beige mortar behind the ceramic wall tile and grout	Kitchen; wall adjacent to the walk-in freezer	Good
Black tar with silver paint	Roof pad and condensing unit pipe penetration sealant	Good

Photo 5: Asbestos-containing mortar behind to the non asbestos-containing glazed white ceramic wall tile and grout adjacent to the walk-in freezer.
Non lead-based glazed white ceramic coating.

The ACM was found to be in good condition and no immediate abatement action is necessary. However, due to the likelihood of disturbance during the renovation, the material must be removed prior to the renovation activity. All removal must be completed by a certified asbestos abatement contractor under controlled conditions in accordance with EPA and Hawaii Department of Health (HDOH) regulations. Work should also be monitored by an independent industrial hygiene professional.

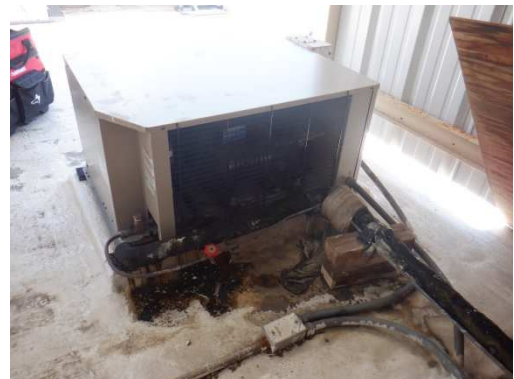
Photo 6: Non asbestos-containing black foam and adhesive pipe insulation connecting the condensing unit.

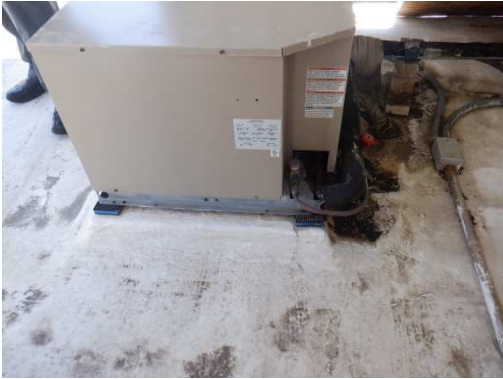
Photo 7: Asbestos-containing black tar/silver paint on the roof pad and pipe penetration sealant.

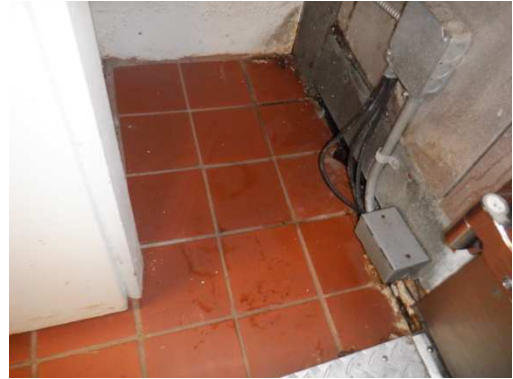
Photo 8: Kitchen red quarry floor tile. Non lead-based glazed red coating.

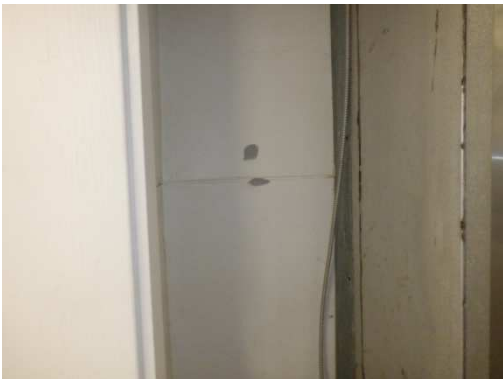
Photo 9: Plaster wall adjacent to the freezer. Non lead-based beige paint.

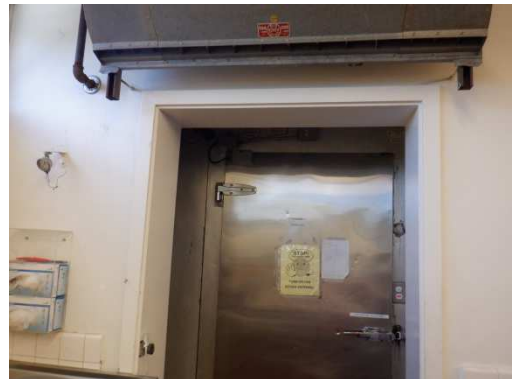
Photo 10: Wood door frame. Non lead-based white paint.

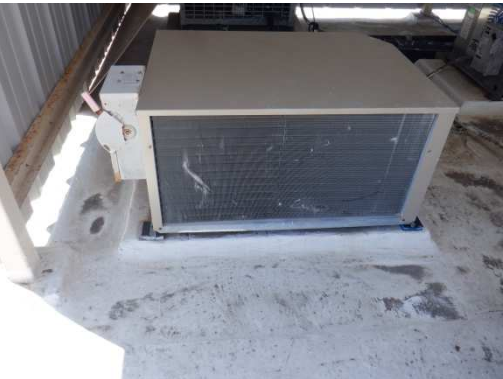
Photo 11: Roof. Non lead-based beige elastomeric paint/ coating.

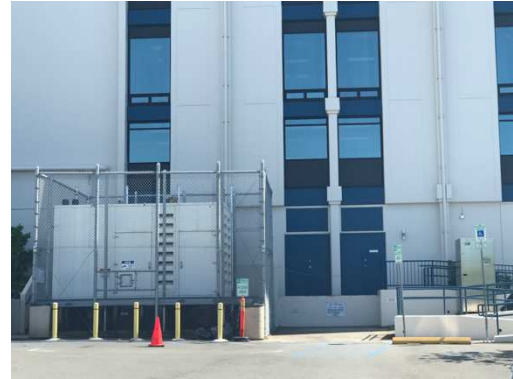
Photo 11: Concrete exterior wall. Non lead-based beige over tan paint.
