## MALUHIA, A LONG TERM HEALTH CARE FACILITY

- FROM: Scott Kawai *And Kawa* Contracts Department
- SUBJECT: Addendum No. 1 IFB No. 22M-0337 Maluhia Renovation of Rooms

## LIMITED INSPECTION REPORT FOR ASBESTOS AND LEAD-BASED PAINT

Maluhia Hospital Window Replacement

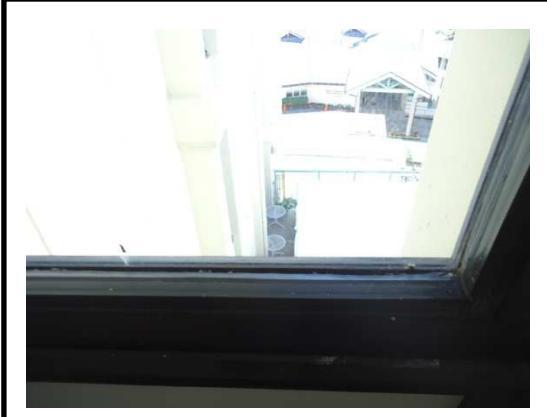
Photo 1: 3<sup>rd</sup> floor (typical of basement, 1<sup>st</sup>, and 2<sup>nd</sup> floors also).

Non-asbestos containing black caulking around the window frame.

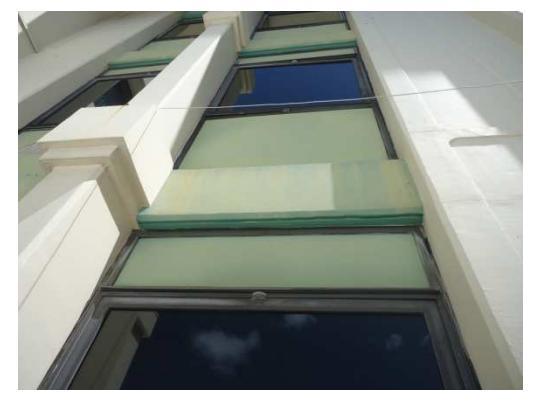
Photo 3: 3<sup>rd</sup> floor (typical of basement, 1<sup>st</sup>,and 2<sup>nd</sup> floors). Exterior view of asbestos-containing green painted cementitious panels.

The ACM was found to be in good condition and no immediate abatement action is necessary. However, due to the likelihood of disturbance during the renovation, the material must be removed prior to the renovation activity. All removal must be completed by a certified asbestos abatement contractor under controlled conditions in accordance with EPA and HDOH regulations. Work should also be monitored by an independent industrial hygiene professional.

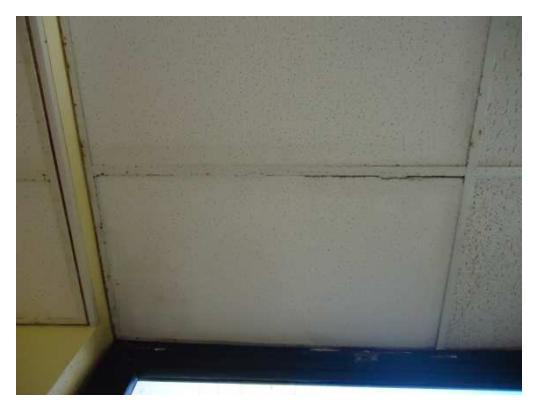
Photo 5: 1<sup>st</sup> floor, adjacent to Sun Deck. Non-asbestos containing 2'x4' pinhole design ceiling tile.

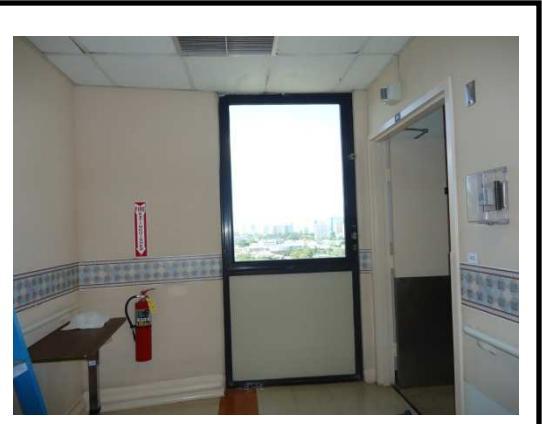
Photo 2: 2<sup>nd</sup> floor (typical of basement, 1<sup>st</sup>and 3<sup>rd</sup> floors).

Interior view of asbestos-containing white painted cementitious panel under the window.

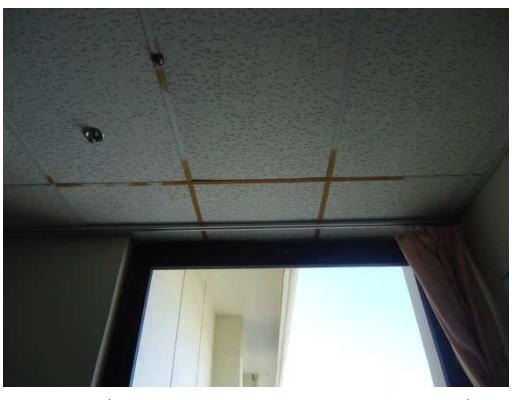
Photo 4:  $3^{rd}$  floor (typical of basement,  $1^{st}$ , and  $2^{nd}$ ). Non-asbestos containing 2'x4' fissured and pinhole design ceiling tile.

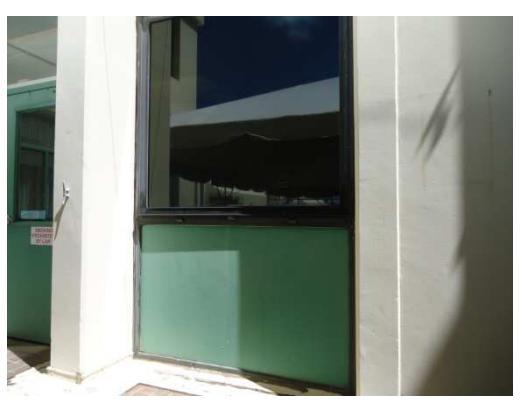
Photo 6: 1<sup>st</sup> floor, Sun Deck. Non-asbestos containing hard black caulking, black rubber-like caulking, and gray caulking around window frame.

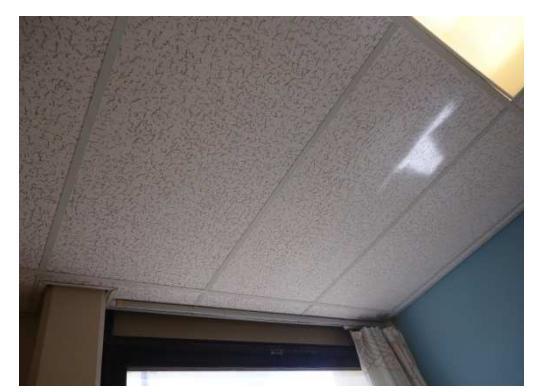
Photo 7: Basement, CSR. Asbestos-containing 2'x4' ribbon fissured and pinhole design ceiling tile.

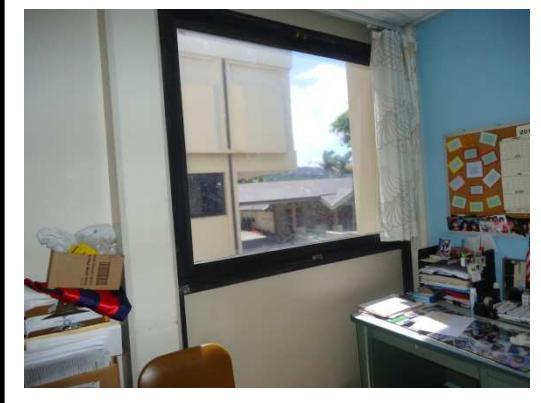
Photo 9: Interior, typical of windows Non-lead based painted white concrete column, wall, and cementitious panel.

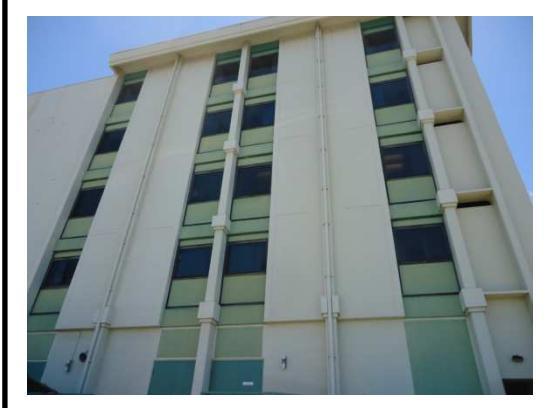
Photo 11: Exterior. View of asbestos-containing cementitious panels under and above the windows.

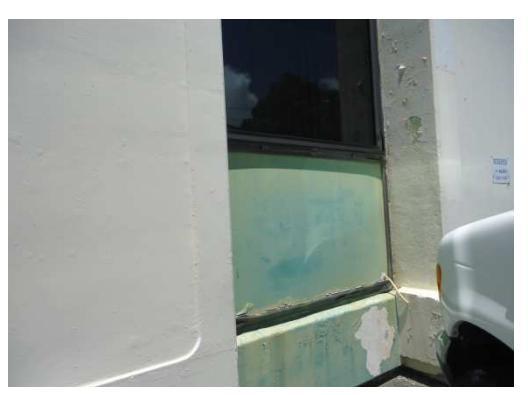
Photo 8: 1<sup>st</sup> floor, exterior window frame Non-asbestos containing white chalky coating, black caulking, and dark gray caulking.

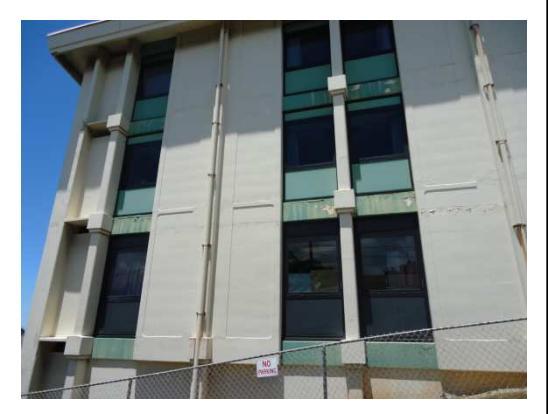
Photo 10: Exterior. Non-lead based painted white concrete column and wall. Non-lead based painted green cementitious panels.

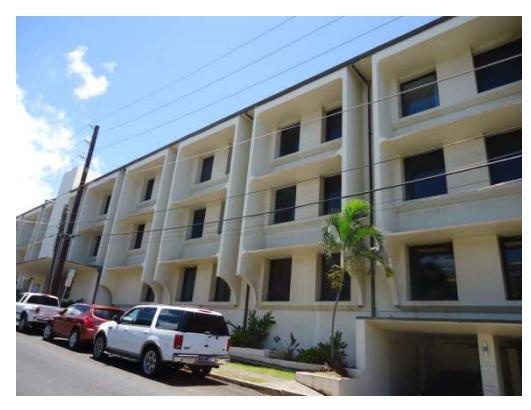
Photo 12: Exterior. View of windows without asbestos-containing cementitious panels.
